ZEROCIVIL

ZC-TEST-001

INDEPENDENT ENGINEERING TESTING

The world's first means of securing bollards
preserving pavements and concrete foundations for the life of a
development and making bollards reusable following even severe impact

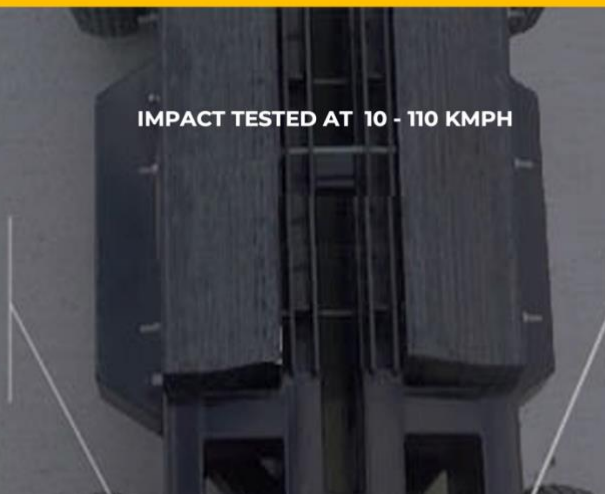
LOW SPEED IMPACT

The bollard has a shock absorbing mechanism that absorbs the impact force and allows bollard to deflect to a maximum of 20 degrees and self recover.

HIGH SPEED IMPACT

The bollard has a strong resistance core that slows the vehicle or brings it to a stop and makes both the bollard and footings reusable following even severe impact.

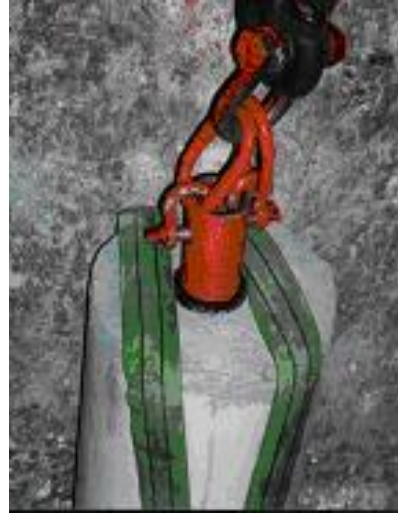
Subject: To confirm holding capacity of the ZERO WASTE Foundations (ZWF)

All components were in an ambient temperature of 18 degrees centigrade. The ground tube and the Tapers were moulded in medium flow black polypropylene. The taper on the inside of the ground tube and the outside of the Tapers was 1° from vertical.

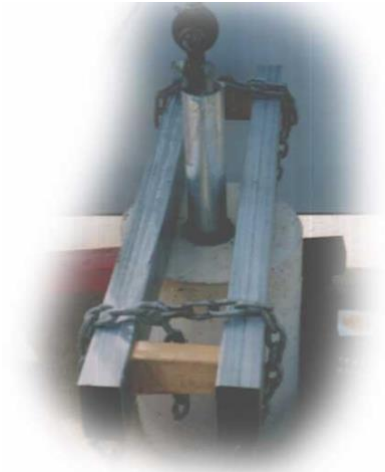
Equipment used:

- A traceable NATA calibrated tension load cell
- Horizontal tested machine, which is operated by one hydraulic ram.
- Client supplied "ZERO WASTE Foundations" consisted of the following:
 - Two half circle tapered plastic Tapers 275 mm in length, secured to the sign post by means of self-drilling screws.
 - A tapered polypropylene ground tube (ZERO WASTE self-healing ground socket), 350 mm in length, cast in a concrete block.

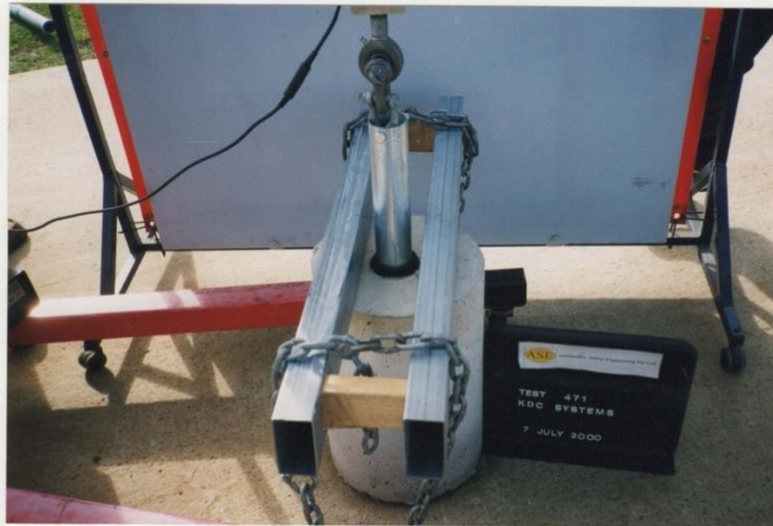
Figure 4.1.1. Test 471 Static pull force - wedge at 10mm above the concrete surface.

4.1. Tests 471 - STATIC PULL FORCE - Wedges 275mm long

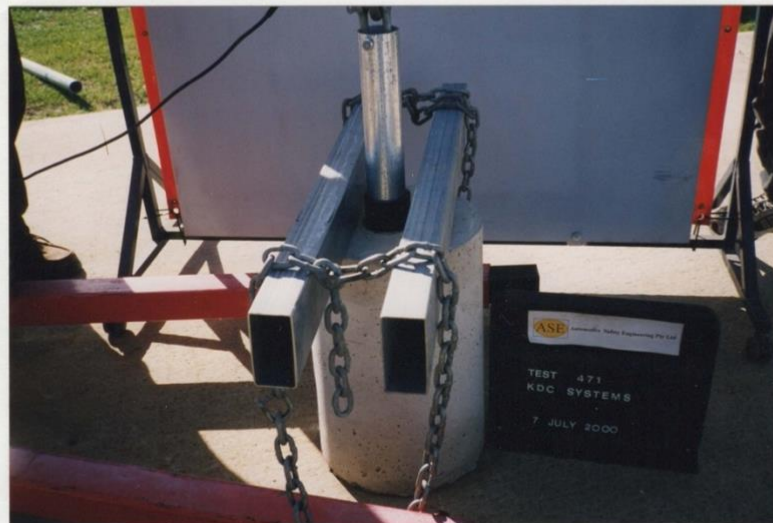
Figure 4.1.2. Test 471 Static pull force - wedge at 10mm. Maximum force 3,188N.
(325kgf)

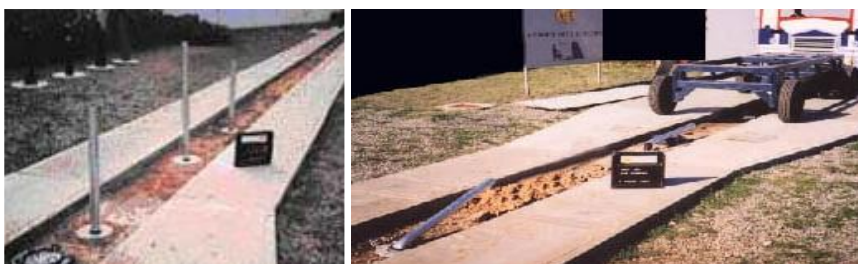
Subject: To confirm the post will bend at the surface of the ground and to determine that the ZERO WASTE socket will hold in the concrete base when impacted.

Two 350 mm ZERO WASTE sockets were installed in a concrete footing 300 mm x 300 mm in an impact test bed. A 60OD /50NB signpost fitted with Self-locking Taper (sleeves) was installed in one ground tube (ZERO WASTE socket) that was cast in a concrete test bed with 10 mm of the Tapers showing above the ground tube (ZERO WASTE socket). The sign post was impacted with a test trolley weighing 1800 Kg at a controlled speed of 60 Km/H, the impact point was 420 mm above ground level representing the height of an average car bumper height. The effort required to remove the impacted signpost was 302 Kg/f.

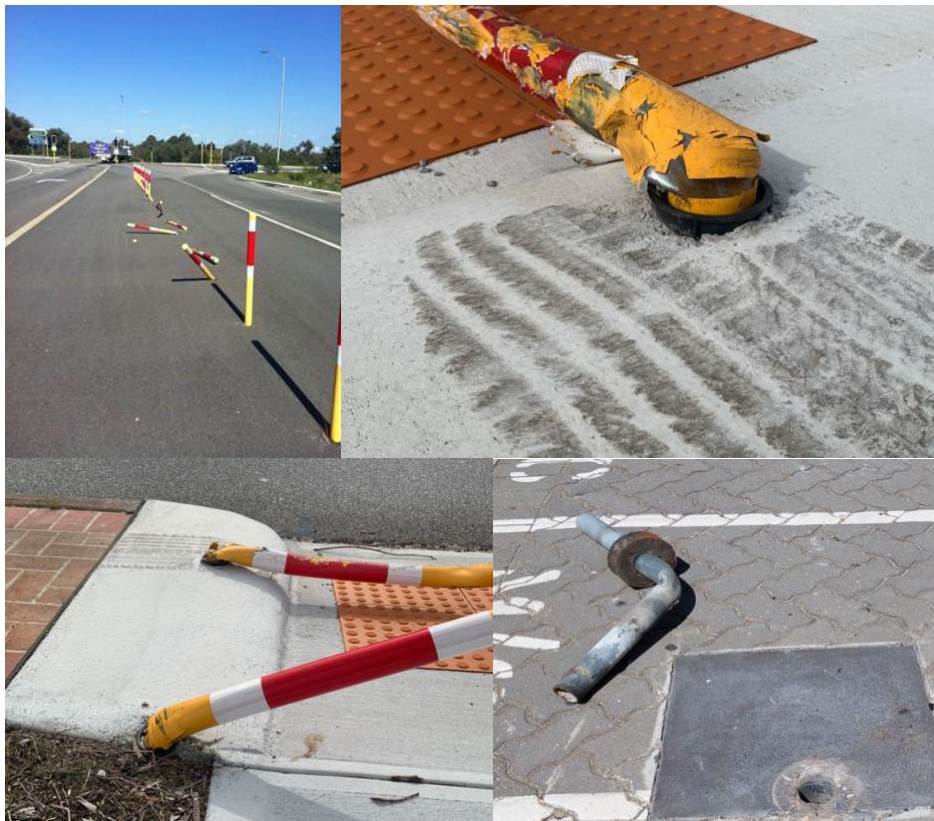
IMPACT TESTS FOR IMPACT RECOVERY SYSTEM

The bollard deflected approximately 20 degrees upon impact and returned upright without damage to the Impact Recovery System, the bollard or the concrete footings/ paving.

The process was repeated using an Advanced Polymer bollard with a 400 mm square and 700 mm deep concrete foundation installed directly into soil (and secured to surrounding concrete foundation).

It was impacted using a utility vehicle with bumper bar. This test provided the same results. No evidence of damage to the concrete foundations or bollard after numerous impacts.

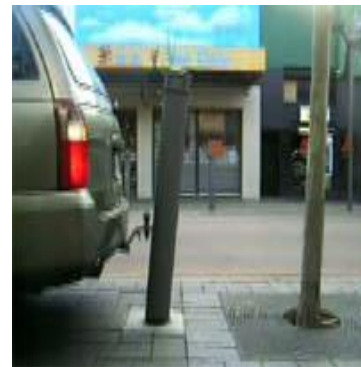
A 650 mm Ground socket was installed in a concrete footing 400 mm square and 700 mm deep. A 60OD (2.9 wall thickness) post fitted with a Self-locking Taper was installed in the ground tube that was cast in a concrete test bed with 10 mm of the Tapers showing above the ground tube The Impact Recovery Rings and Bollard were secured to the post.

The bollard was impacted with a vehicle at low-speed, the impact point was 420 mm above ground level (the height of an average car bumper).
